# Manhole Inspection Summary

Manhole # S37KK\_030MH

Insp Date: **3/19/07 11:53 AM**

**Location** Address: **1803 BARCLAY ST**

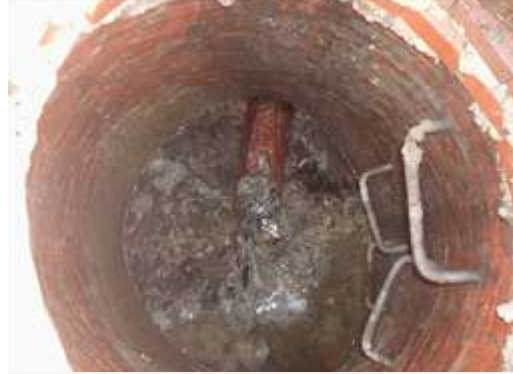
Top View

**Bench** ☒ Exists Material: **Brick** ☐ Parged ☒ **Debris** (not Condition related)

Condition: ☐ Sound ☐ Cracked ☐ Root Intrusion ☐ Deteriorated ☐ Leaks ☒ **Debris**

**Surcharge** ☒ **Evidence Of Surcharge** Depth: **4** (ft.) ☒ **Active Surcharge Present**

Evidence of surcharge - Bench debris.  
Channel debris.

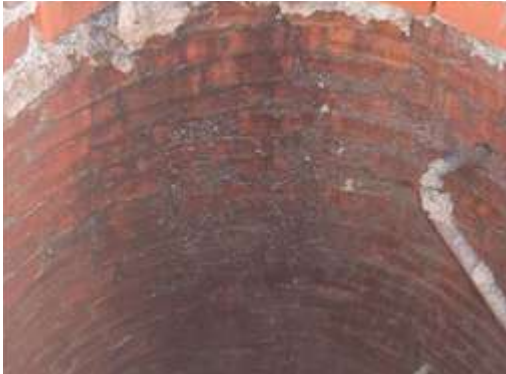
Defect

**Frame** Offset: **0** (in.) Condition: ☐ Sound ☐ Cracked ☒ **Leaks**

Condition: ☐ Sound ☐ Cracked ☐ Root Intrusion ☒ **Loose Brick** ☒ **Deteriorated**

Infiltration: ☐ None ☒ **Joint** ☐ Cracks ☐ Mortar ☐ Roots ☒ **Wall**

Frame leaks. Adjustment deterioration,  
loose brick and infiltration - other side.

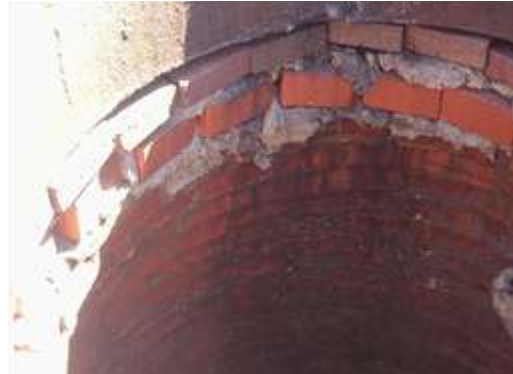
Defect

Frame leaks. Adjustment deterioration,  
loose brick and infiltration.

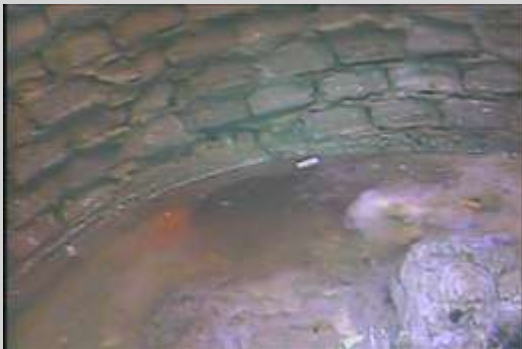
### 8 in. Circular Gravity Sewer Pipe In @ 5 O'Clock

Barrel deterioration and infiltration.

Deposits: ☐ None ☒ **Mud** ☐ Sludge ☒ **Debris** ☐ Grease

Silt Depth: **7** (in.) Deposits Extent: **Heavy**
